## METALOCK REPAIR REPORT

Engine Maker : YANMAR CO. LTD.  
Engine Type : 8N21L-SV  
Engine Cont. Rating :880 KW  
Repair Company :METALOCK INTERNATIONAL / 20.01.2015  
Repair Description:

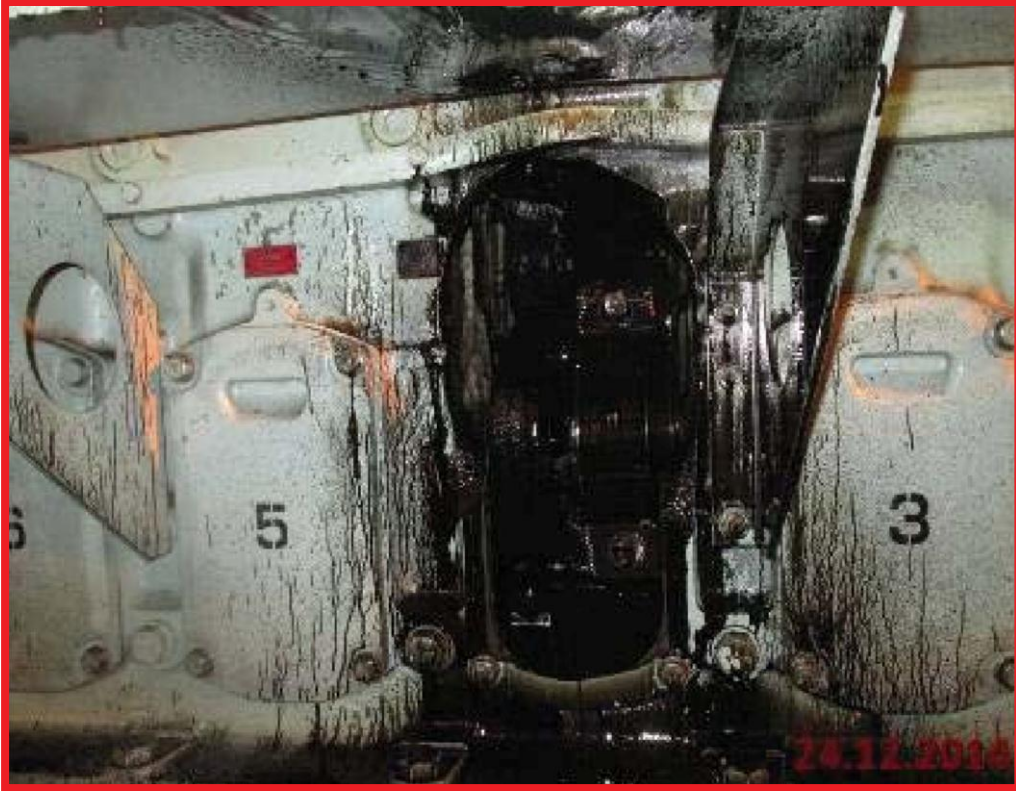
Summary & Conclusion: Due to connecting rod bolt failure rod bottom bearing shell cap broke through the engine frame and caused cylinder block damage. Metalock repair proposal is that damaged part shall be fabricated by casting from proper material after material analyse of original cylinder block. Analyse report shall be provided accordingly. Fabricated part shall be installed by metalock repair procedure.
