MV PACIFIC VICTOR
MAN – HENAN DIESEL ENGINE INDUSTRY
CO.LTD. P.R.C
TYPE:6L 16/24 CFB
SERIAL NO: 6A6C00065/66/67
DAMAGED D/G CYL.BLOCK REPAIR WITH
METALOCK

REPAIRED REPORT

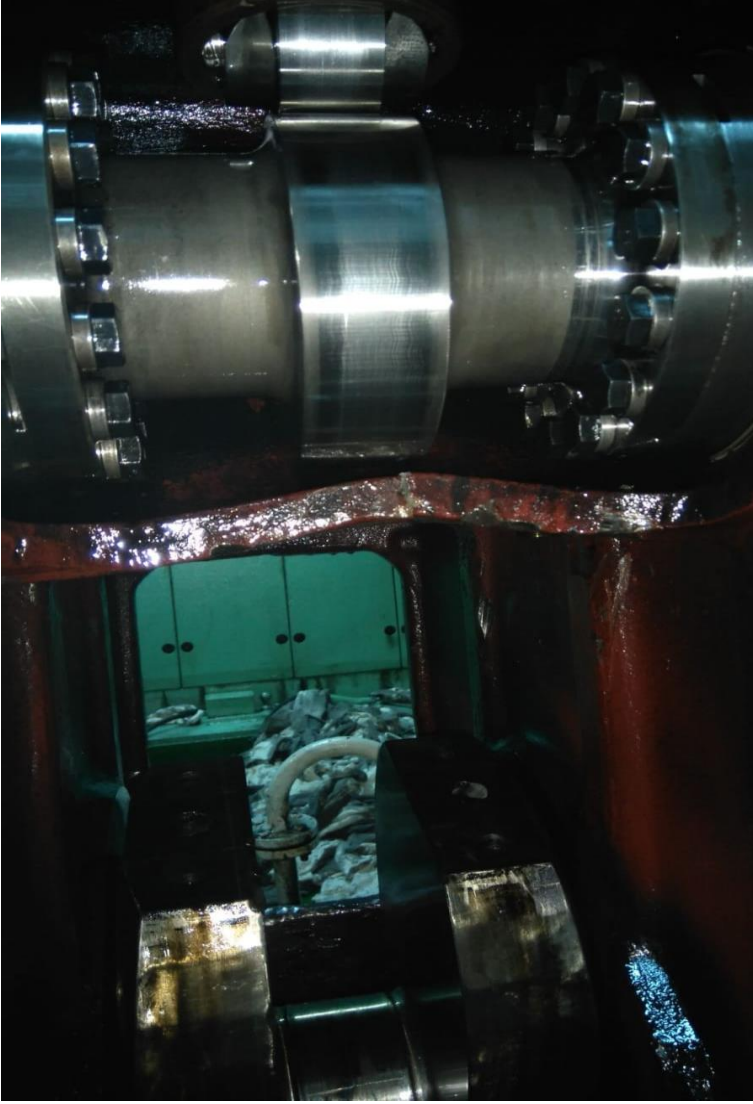
It was determined damaged area.
